Draft Translation 625
July 1977

CONSTRUCTION AND OPERATION OF LOW-PRESSURE DAMS ON PERMAFROST SOILS

G.F. Biyanov

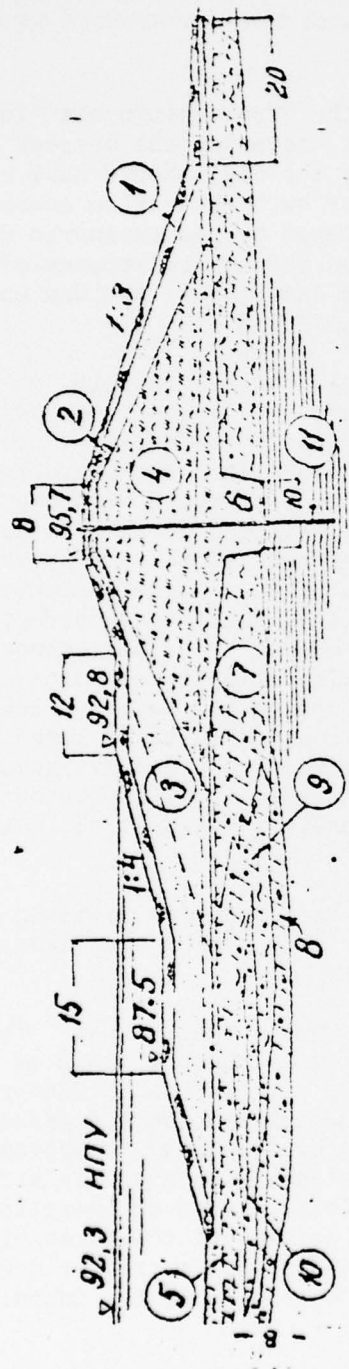
Figure 1. Dam No. 1: 1 -- rock rubble reinforcement of slope; 2 -- moss-peat heat-insulating layer; 3 -- sand fill; 4 -- loamy clay core; 5 -- boundary of permafrost; 6 -- loamy clay tooth of dam; 7 -- swollen silted loamy clay, up to 60% ice content; 8 -- loamy clay with marl rubble; 9 -- silty loam with gravel, rubble; 10 -- sand with plant fossils; 11 -- frozen curtain wells.
[HПV=Normal backwater level]

According to the blueprint, drafted by the "Tsvetmetproyekt" Institute, these loose, ice-swollen Quaternary sediments, covering the bedrock in a layer up to 3 m thick under the foundation of the dam, should have been replaced by high-quality soils. The volume of such excavation amounted to more than 130,000 cm³. The blueprints, developed by the Leningrad department of the "Gidroproyekt" Institute, retained the entire stratum of Quaternary sediments in the foundation of the dam. Thus, the dam was [possibly planned] on unreliable ice-saturated soils.

Changes were later made in the construction of the facility at the suggestion of the builders. In particular, a tooth, which completely cut through the ice-saturated Quaternary, less reliable (in terms of bearing capacity), ice-saturated soils, and extended 0.5 m into the bedrock, was constructed for the purpose of fastening the body of the dam to the foundation. The width of the tooth was [one word illegible] at 12 m in accordance with construction conditions, but it was later reduced to 8 m. Such mating of the core of the dam and the bedrock, which has a low ice content, and which retains its bearing capacity after thawing, guaranteed perfect anti-filtration stability and the reliability of the dam. In this connection the builders suggested constructing the dam without a frozen curtain, since during construction of the tooth, which cut through the entire thickness of the Quaternary sediments, such a measure was considered to be largely superfluous, substantially increasing construction cost and overhead. However, the suggestion of the builders was rejected. It is important to note here that the plan of the spillway was completely revised at the suggestion of the builders.

The dam was placed in operation in 1964 and continues to be in satisfactory condition. The frozen curtain in the body of the dam makes perfect contact with the frozen foundation.

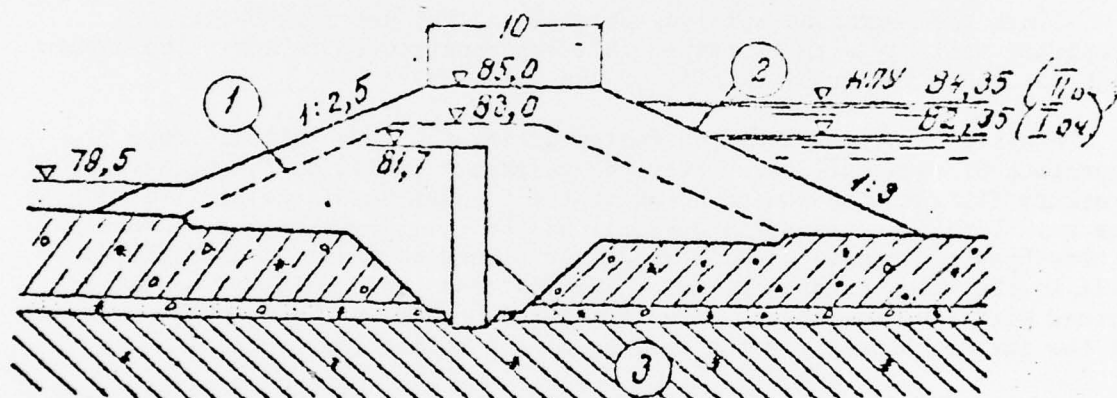
During the course of construction the plan of the dam was altered in order to increase the capacity of the reservoir; its height was increased by 2 m. The dam was widened by filling the slopes with argillaceous loamy clay with up to 35% rock rubble.

Figure 2. Dam No. 2: 1 -- contour of initial dam; 2 -- contour of dam after reconstruction; 3 -- cribwork diaphragm.

Flaws of the plan were manifested during the very initial stage of operation of the facility. After the reservoir filled to the planned level pressure filtration began to occur in the foundation of the spillway due to the weak bonding of the cribwork sill of the spillway with the foundation. A clay upstream puddle blanket was later placed in front of the spillway sill in the water intake channel. The upstream puddle blanket was reinforced with concrete slabs. A cofferdam was built in the entrance section of the intake channel for the purpose of completing this work.

6. The construction of a cribwork diaphragm in the body of an earth-fill dam cannot be considered correct. It is virtually impossible to mechanize the filling and compaction of soil along the contour of a cribwork and in its cells, and manual compaction is unproductive and, more importantly, its quality does not readily yield to control. Furthermore, because of varying degrees of settling of a relatively rigid cribwork construction with [possibly vertical] walls and of the earth-fill body of a dam at the interface of the soil and cribwork, cracks inevitably form.

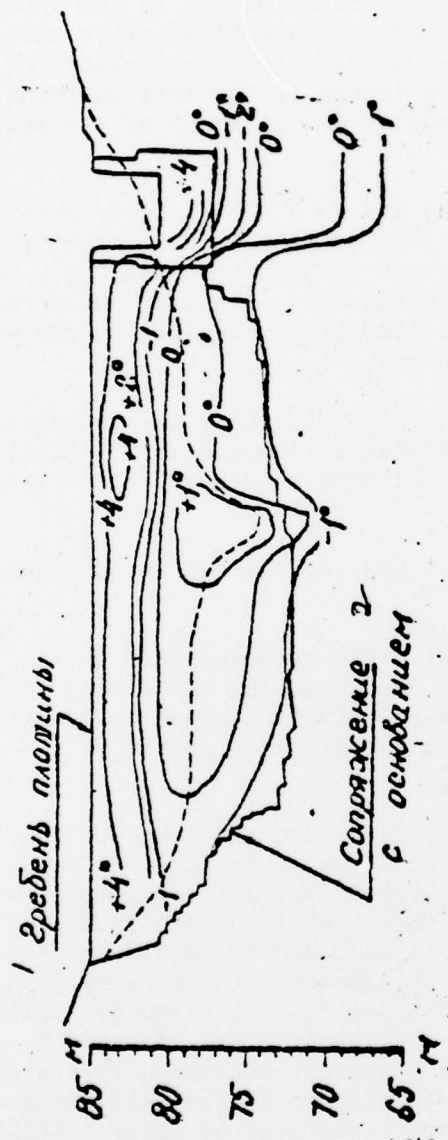
During the first year of operation the zero isotherm in the foundation of the dam fell by 1.2 m, and by 1.4 m more during the second year, under the influence of the filtration stream. Thus the upper boundary of the [one word illegible] fell by 2.8 m in 2 years as a result of the filtration stream.

Figures 3 and 4 show the isotherms through the longitudinal cross section of the dam for 1 June 1960 and 1 [possibly June] 1961. The figures show that the left bank flood plain part of the dam completely froze and the core of the thaw zone shrank in the area of the bed section. The zero isotherm under the spillway dropped to 12 m due to considerable filtration through the fissured bedrock. This degradation of the permafrost under the spillway does not pose a danger to the dam itself, since the spillway was built on soils, the bearing capacity of which is not affected by a change of the thermal [one word illegible]. However, increased filtration may result in [possibly heating] of the foundation in the spillway abutment and lead to increased filtration [one word illegible] of water. This assumption was eventually confirmed. Filtration decreased as the water level of the reservoir fell. When the water levels in the reservoir fell to the crest level of the temporary cofferdam in the intake channel filtration of water into the lower reach ceased. This showed that the source of the filtration stream was located in the intake channel between the temporary cofferdam and the spillway.

Figure 3. Isotherms in body of dam on 1 June 1960.
KEY: 1, Crest of dam; 2, Foundation abutment.

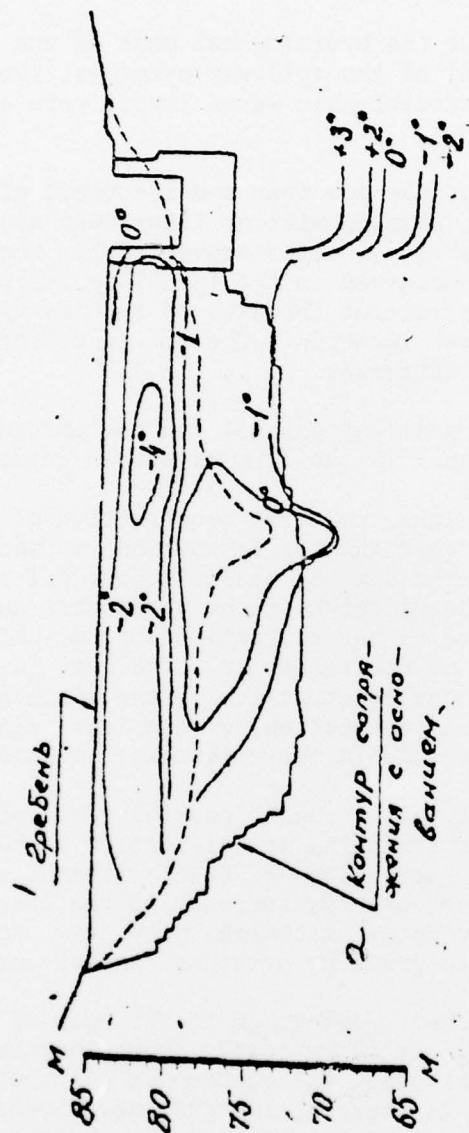
Figure 4. Isotherms in body of dam on 1 June 1961.
KEY: 1, Crest; 2, Contour of foundation abutment.

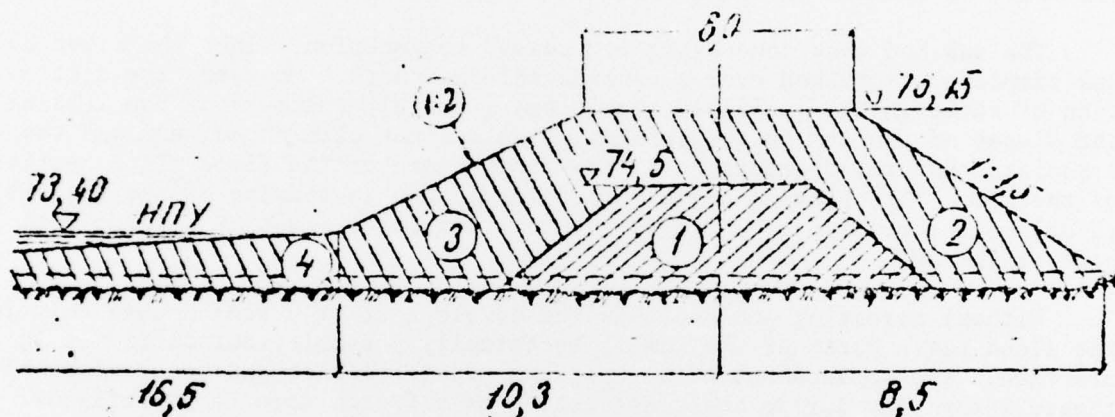
The earth-fill dam with a frozen core is [number illegible] m long, has a maximum height of 4.1 m and creates a 1.5 m pressure head (Figure 5). The frozen core of the dam, which acts as an antifiltration curtain, was built by layer-by-layer packing of frozen soil, flooded with water and allowed to freeze. The volumetric ratio of ice to soil was 1:1 and the density of the ice-soil [possibly curtain] is 1.2-1.5 t/m³ [2]. The top of the frozen core of the dam, [possibly built] during the winter (February-March), is covered with a buffer heat-insulating layer of earth to a depth exceeding the depth of seasonal thawing of the soil in the vicinity of the construction site.

Figure 5. Dam No. 3: 1 -- frozen core; 2 -- lower wedge of dam filled with frozen soils; 3 -- frozen soil fill; 4 -- shield and upstream puddle blanket of thawed soils.

The sub-bed thaw zone basically ceased to function, since the river bed was completely scrubbed over a considerable distance. However, the filtration of water in the [possibly receiving] [possibly contour] of the threshold and slopes of the dam on the spillway side was not eliminated, nor was the associated natural degradation of the frozen core of the flood plain sections of the dam. This process began to accelerate due to thawing of the [possibly floor] of the reservoir, and a frozen core ceased to exist as a structural part of the dam.

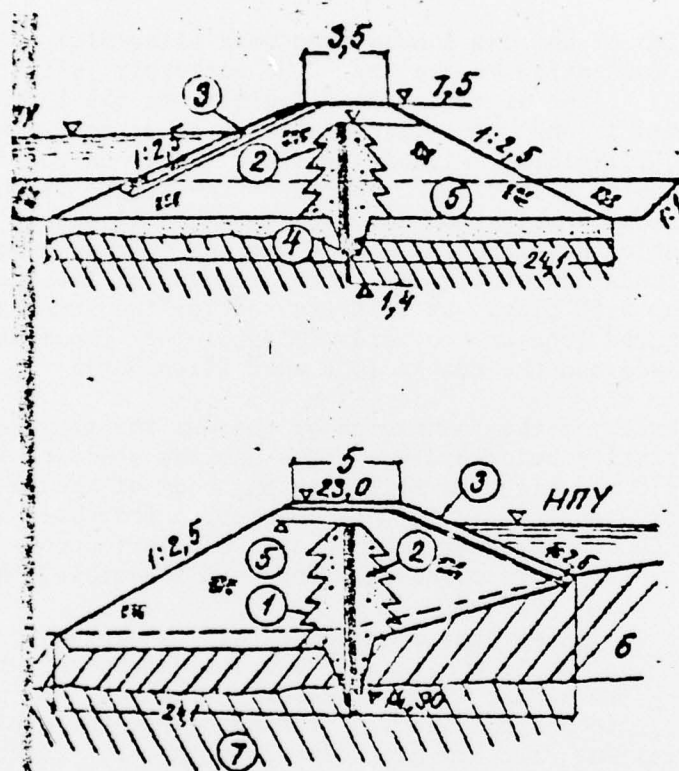
Both dams are structurally identical and are built of marlaceous soil with an antifiltration curtain made of wood panels. The body of the dam is mated with the foundation by an up to 2.2 m deep tooth with a trench in the less ice-saturated bedrock.

Figure 7. Dams No. 6 and 7: 1 -- wood panel diaphragm on [one word illegible] pilings; 2 -- sand-gravel core; 3 -- [one word illegible] with small rocks; 4 -- clay lock; 5 -- body of dam; 6 -- ice-saturated clay with rubble; 7 -- marlaceous rock.

During the spring-summer period of the first year of operation thawing of the frozen marlaceous loamy clays by [possibly self-compaction] resulted in up to 50 cm of subsidence. However, the dams were filled with a margin against the projected height by [illegible] cm. During the first year of operation, one day after [one word illegible] of the planned pressure head, filtration of water was observed in the left bank part of the upper slope, with a discharge rate of up to [illegible]. The presumed cause of filtration was misalignment of the diaphragm panel joints as a result of inadequate [one word illegible] filling and packing of the frozen chunk clay. Filling of the lower slope of the dam at the point of discharge of the filtration stream with local thawed soil stopped [one word illegible], and then filtration completely ceased. This dam has exhibited no filtration phenomena since then. During the first weeks of operation the pumping station operated with interruptions, the reservoir filled and the water level in it rose above the [one word illegible] of the top of the antifiltration diaphragm, but no undesirable consequences were observed. Both dams have been operating satisfactorily for [one or two words illegible].
